ANALYSIS OF SERVICE OF REFRACTORIES IN GLASS-MELTING TANK FURNACES

V. D. Tokarev,¹ S. S. Igat'ev¹, and O. N. Popov¹Translated from *Steklo i Keramika*, No. 5, pp. 19 – 22, May, 2006.

The fundamental issues of extending the period between repairs for glass-melting tank furnaces are analyzed. Based on data obtained in studying refractory brickwork after the furnace has been stopped for a cold repair and analyzing the specifics of corrosion of refractories in various structural elements, technical solutions are proposed and implemented enabling one to extend the tank furnace campaign to 7 – 8 years.

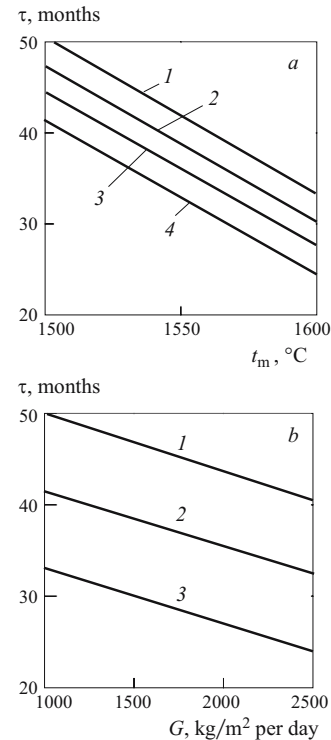
and the specific output of glass melt per surface area of the melting zone of the furnace. Summarized data on the effect of the specified factors on the rate of corrosion of this part of the wall to a residual thickness of 30 mm are given in Fig. 2. The initial thickness of the beams was equal to 250 mm and the intensity of forced air cooling of their external surface was $0.7 - 0.8 \text{ m}^3/\text{sec}$ per 1 m of brickwork.

The analysis of obtained dependences demonstrates that the maximum melting temperature t_m has a significantly greater effect on the rate of the wall corrosion at the glass melt level expressed via the time τ of reaching the residual thickness of 30 mm than the specific melt output G . Thus, raising t_m by 50°C (from 1550 to 1600°C) with $G = 1500 - 2000 \text{ kg/m}^2$ per day shortens the time of reaching the residual thickness of 30 mm by 30–35%, whereas an increase in G by 500 kg/m^3 per day (from 1500 to 2000) at $t_m = 1550 - 1600^\circ\text{C}$ decreases it by only 7–9%. Evidently, the effect of the kinetic factors on accelerating the corrosion process has more weight than the mechanical factors, considering the low velocity of glass melt near the walls of the melting tank wall (up to 10 m/h). Note that the insignificant effect of glass melt flows on the destruction of the melting tank walls is noted in the classical work of Prof. N. V. Solomin.

The dependence shown in Fig. 2 makes it possible to justify the time of installing additional plates on the melting tank wall at the glass melt level, which is currently considered the most efficient solution extending the service life of this brickwork element. Thus, in a furnace with $t_m = 1550^\circ\text{C}$ and $G = 1500 \text{ kg/m}^2$ per day using domestic refractory bacor 33, new plates have to be installed after 33–39 months of service, whereas in a furnace with $t_m = 1600^\circ\text{C}$ and $G = 2000 \text{ kg/m}^2$ per day new plates have to be installed after 26–28 months. Note that the use of more resistant refractory materials or more intense forced air cooling may significantly extend the initial period of failure-free service of this brickwork element up to the first installment of additional plates.

Fig. 2. The duration of corrosion of beams of melting tank walls to residual thickness of 30 mm versus the maximum melting temperature (a) under specific glass melt output of 1000 (1), 1500 (2), 2000 (3), and 2500 kg/m^2 (4) per day and versus specific glass melt output from the melting part of the furnace (b) at maximal melting temperatures of 1500 (1), 1550 (2), and 1600°C (3).
